ALL SAINTS CHURCH, MAIN STREET, EATON, NOTTS.

Archaeological Monitoring and Recording

NGR: SK 70129 77937
Planning Ref.: 18/00901/FUL
Faculty Ref.: 182011
PCAS job no. 2630

July 2022

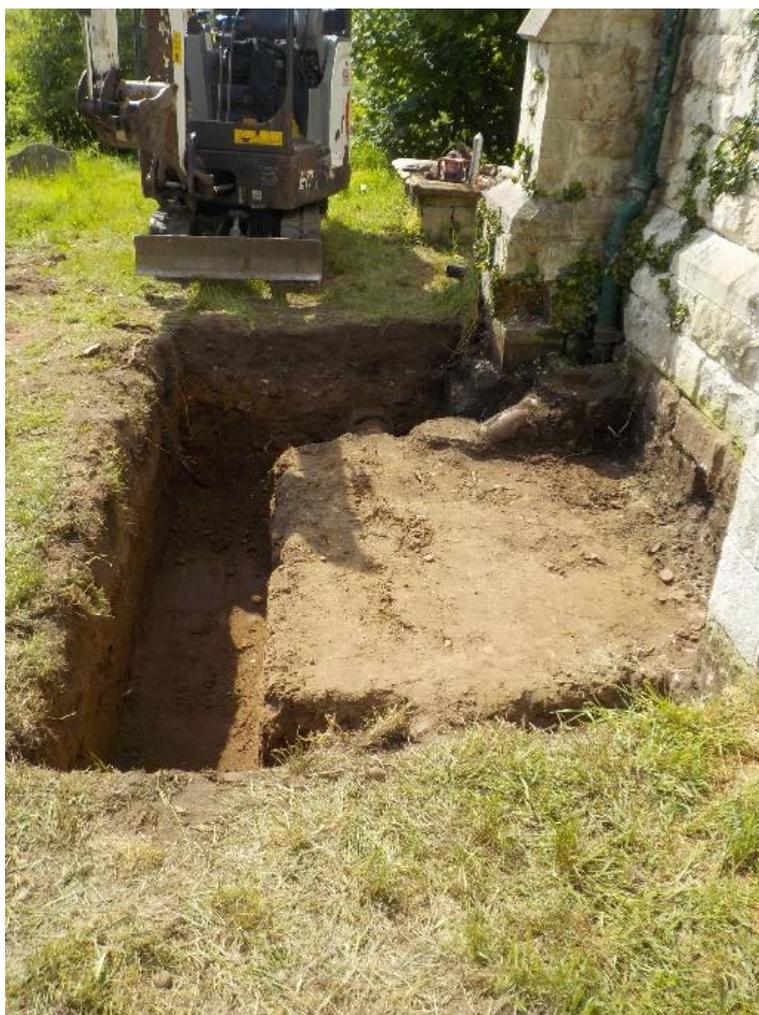
Plate 2: Extension footings (looking W)

Initial excavations focussed on the footings of the extension to the south of the church. These were approximately 0.5m wide and excavated to a depth of 0.9m from original ground level. A stratigraphy of topsoil, (101), overlying a subsoil, (104), was encountered. No archaeological features were seen; however, fragments of disarticulated human bone and modern pottery were retrieved from the subsoil. Two large worked stone fragments were recovered from the topsoil, however no evidence of any earlier foundations being intact were encountered. The foundation of the current church was examined (Fig. 3b) and these don't appear to have been directly built onto the foundations of the previous structure.

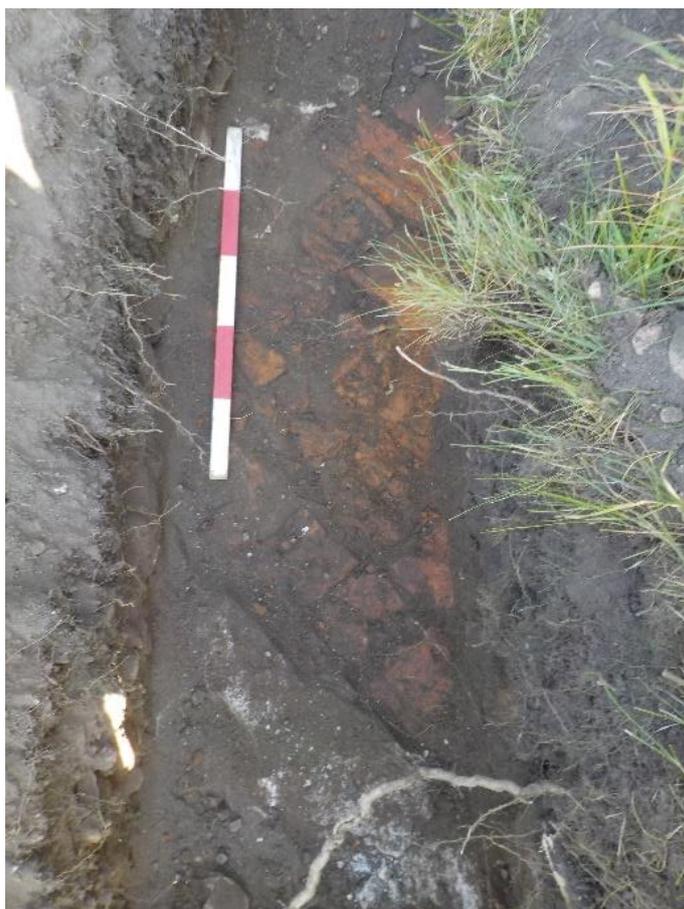
Plate 3: Buried brick pathway (103) (looking N)

Additional groundworks consisted of a long drainage trench, running approximately north to south (see Fig. 2), which connected to the existing drain in the road. This was widened at the southern end, for a soakaway. This was 0.9m wide, 0.6m deep and 7m long. This linked to the toilet facilities via a 0.3m wide drainage channel excavated to the same depth. At the southern end of this, excavations exposed a 0.7m wide surface, (103). This was brick made and was identified immediately below the topsoil, and on top of the buried soil (104). Its route is not immediately obvious, however it's likely that it was a later addition to the grounds of the former church. Potentially as a path leading to a southern doorway.

Direct evidence can be seen in the form of the large limestone blocks and fragments of tracery that were retrieved from the demolition layer, (105), to the west of the current church. The tracery is indicative of 13th century stone masonry and had been carved for a building of relatively high status. In addition to this, the brick-built pathway, not related to the current Victorian church, indicates that the previous building may have had a doorway on its southern side.

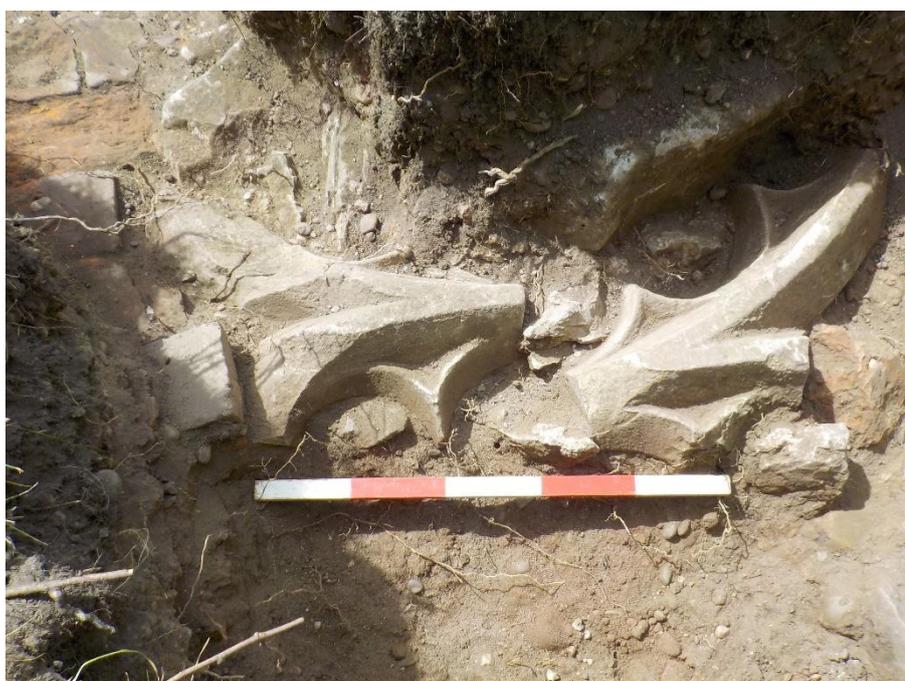
Plate 4: Fragments of tracery seen in (105) (looking SSW)

To the immediate north of the pathway, a large deposit of probable demolition material, (105), was encountered (see plate 6). This contained frequent limestone fragments and several worked stone blocks, although none were identified as being in situ. Further to this, two pieces of carved tracery were recovered (see plate 4 and appendix 2). These were sections of window tracery made in the English Gothic style, from local oolitic limestone. There is evidence on the first fragment of striations to the block joints using a jaded pick or raser, which is consistent with 13th century stonework. The second fragment is near identical in style and is highly likely to be part of the same architectural feature.

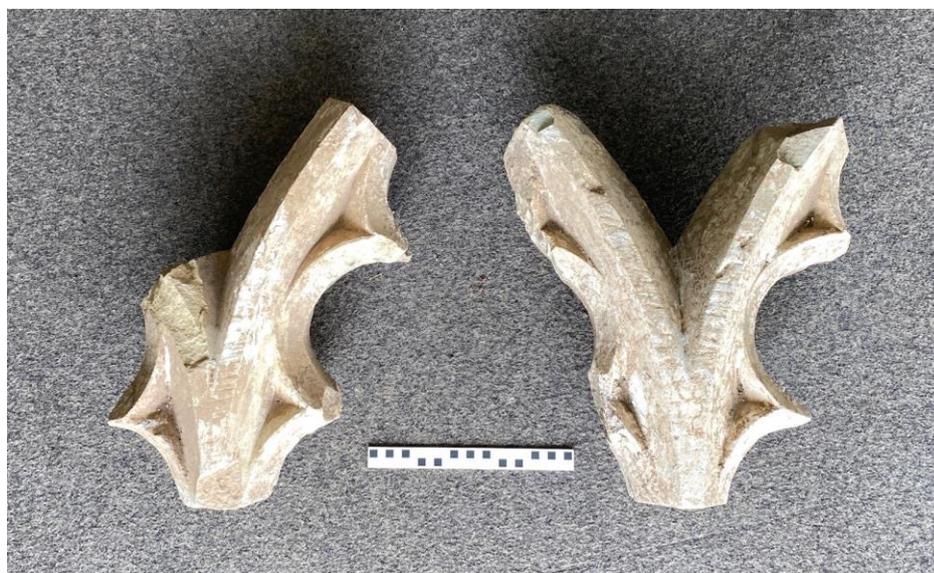
Figure 1 – Fragment No.1 (left) and No.2 (right) from context (102).

This fragment is a section of limestone window tracery in the English Gothic style. Made from relatively local fine grained oolitic limestone, this fragment is finely carved with evidence of finely chiselled surfaces to the internal facets and reveals. The external surfaces show a peck mark finish along with weathering consistent with exposure to the elements.

There is evidence of striations (for mortar keying) to the block joints using a *jadd pick* or *racer* consistent with early to late 13th century stonework (Schofield & Samuel, 2010). The base of the block, where it would rest on the mullion, has a 25mm wide groove cut into it, presumable to facilitating jointing.

The fragment was grooved for fenestration both within the individual lancet and above it. This groove having a significantly greater slope on one side (the building interior) than the other to facilitate the installation of the windows. There is also evidence of some mid greyish mortar or other material on the base and parts of the sides of this fenestration groove. Whilst this may have been some form of bedding compound (mortar?), its nature and function is unclear.

There is also a shallow hole close to the fenestration groove on the outside facet of one of the cusps. This is surrounded by mortar and would have held the saddle bar to support the stained glass panels.

The fragment showed damage to the cusps and most prominent edges and half of one side of the v shape block is missing. The fragment points to the complete piece having rounded three lobed trefoil design to the apex of each lancet.

Another fragment of window tracery recovered along with the previous fragment (No. 1). The shape and dimensions of this fragment and the previous one, show a high degree of similarity and were highly likely to be part of the same architectural feature. This fragment has identical composition and characteristics to fragment No. 1 with the exception that this fragment is less damaged, having the almost complete V shape that would have comprised the sides of the arched tops between two lancets. The groove in the base of the block is absent on this fragment. There were small amounts of residual mortar, paint and distemper present in similar location to the previous fragment.

An analysis of the results listed above indicate the presence of an ecclesiastical building on site of a likely medieval date. The presence of these two carved stonework fragments suggest they originate in a structure of reasonable status.

There was a mild level of surface damage and abrasion on both fragments, but the small amounts of paint and distemper present on the inner surface have remained. This could be from an earlier existing decoration scheme or present as part of the wave of church “restoration” occurring in the early to mid 19thC. With the desire to return to an earlier and plainer interior, many churches were decorated as part of restorative schemes (cf. painted over) to match an earlier aesthetic – that of the 13thC decorated style of church architecture. With the known rebuilding date of the church in 1857-8, these fragments are likely to have come from the medieval church built in the 13th century and present on this site prior to the construction of the current building.
