FOUNDATIONS OF THE DEMOLISHED PORTION OF THE NAVE.

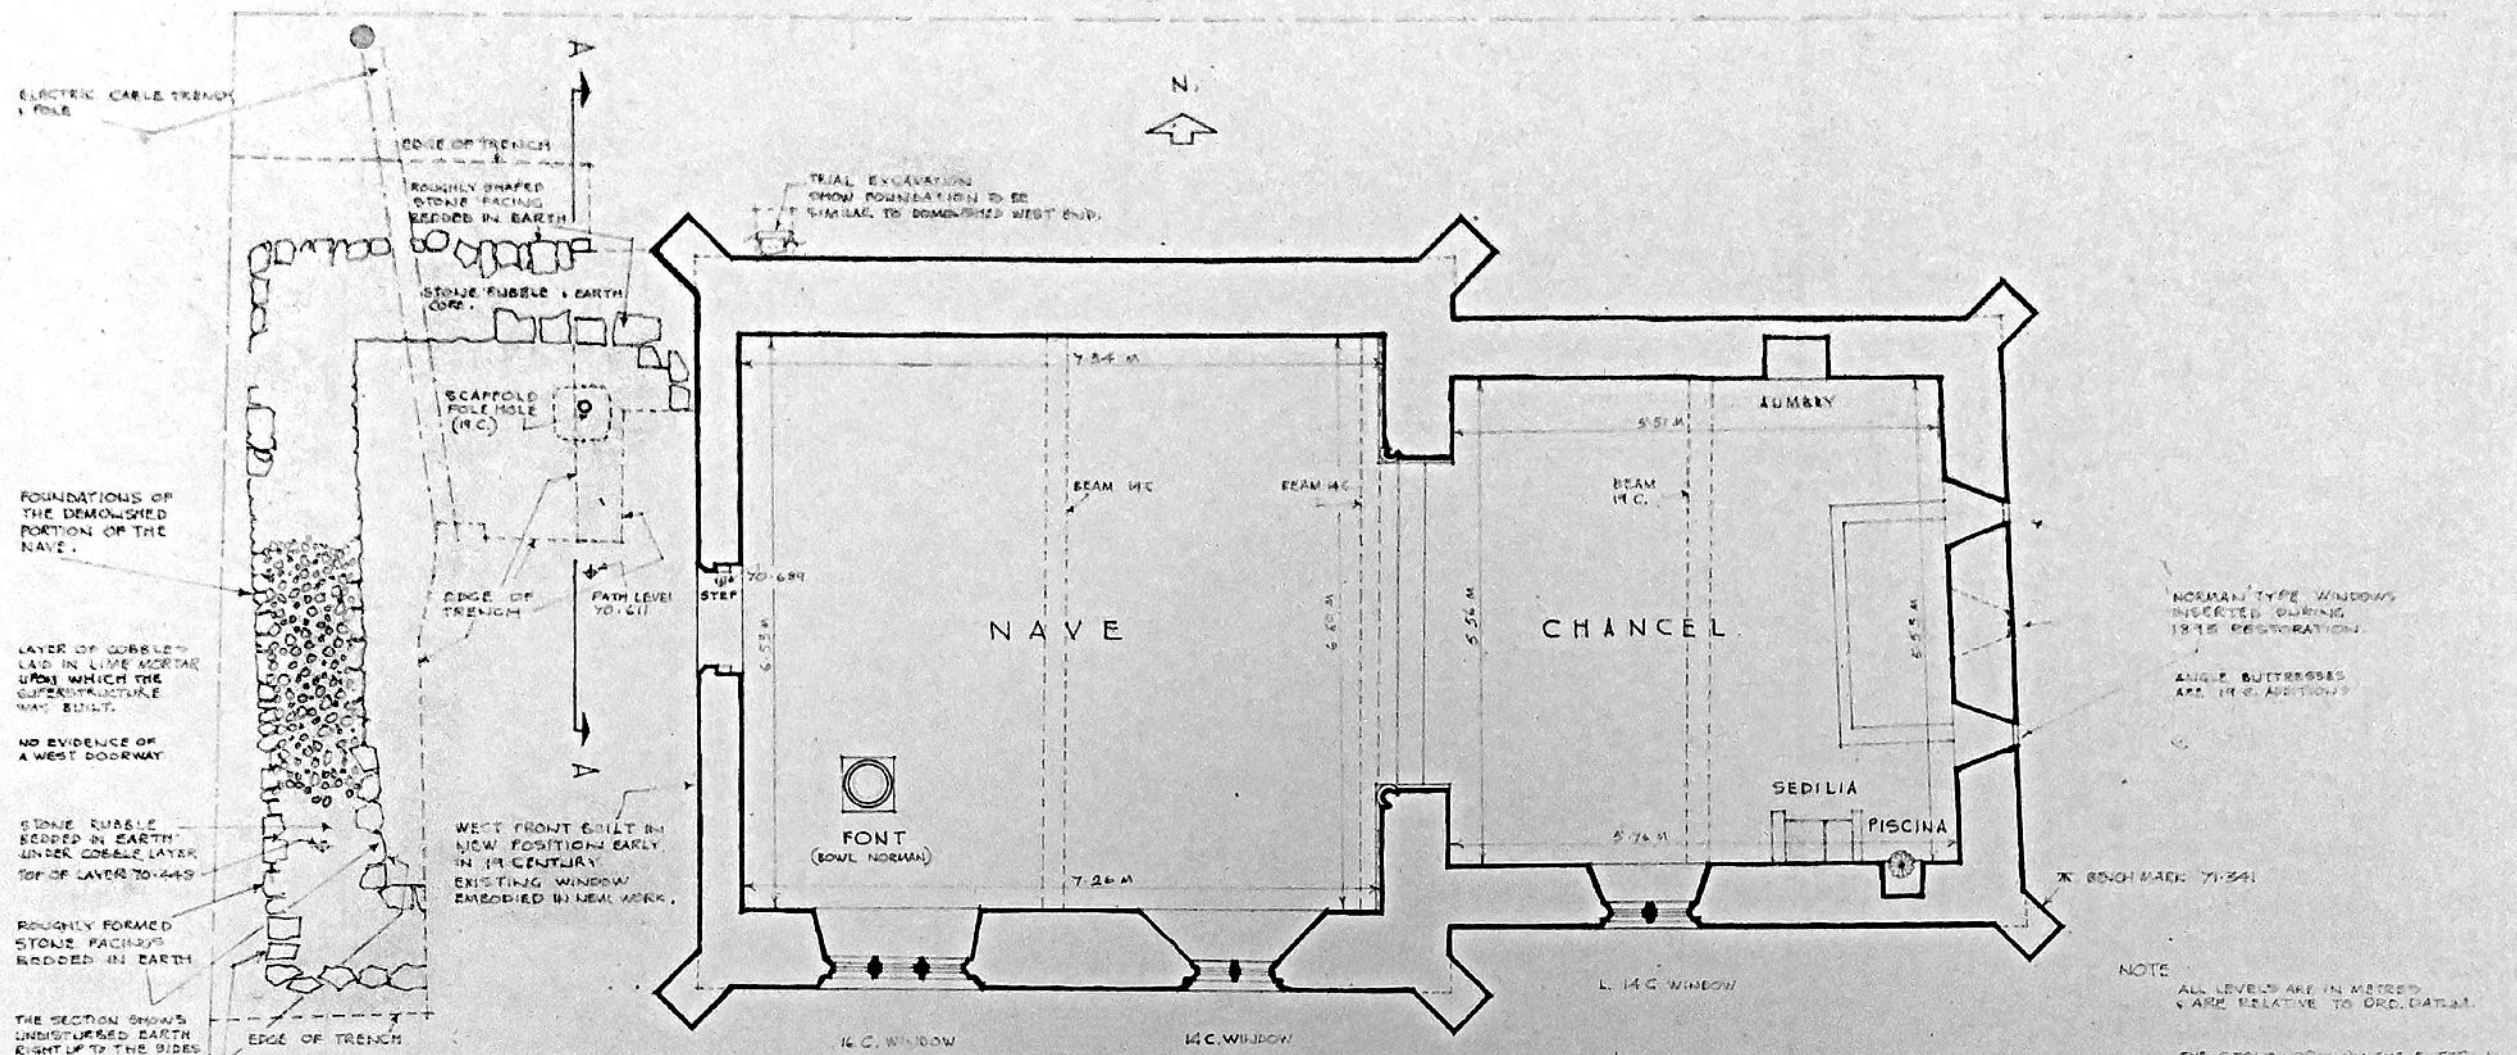
LAYER OF COBBLES LAID IN LIME MORTAR UPON WHICH THE SUPERSTRUCTURE WAS BUILT.

NO EVIDENCE OF A WEST DOORWAY.

STONE RUBBLE BEDDED IN EARTH UNDER COBBLE LAYER TOP OF LAYER 70-449.

ROUGHLY FORMED STONE FACINGS BEDDED IN EARTH.

WEST FRONT BUILT IN NEW POSITION EARLY IN 19 CENTURY. EXISTING WINDOW EMBODIED IN NEW WORK.

TRIAL EXCAVATION SHOW FOUNDATION TO BE SIMILAR TO DEMOLISHED WEST END.

NORMAN TYPE WINDOWS INSERTED DURING 1815 RESTORATION.

ANGLE BUTTRESSES ARE 19 C. ADDITIONS.

THE STONWORK ON THE EXTERNAL SIDE OF THE S WALL OF THE NAVE ABOVE THE APPROX 1 M LEVEL IS REGULAR COURSED SQUARED STONE, COMPLETELY UNLIKE THE STONWORK BELOW & ON THE INNER FACE. THIS, AND THE CONDITION OF THE STRAIG, SUGGESTS A RECASTING, POSSIBLY 19 C. THE 14 + 16 C. WINDOWS, SOMEWHAT RESTORED, BEING EMBODIED.

ANGLE BUTTRESSES ARE 19 C.
